IMI-2 ACCIDENT SCENARIO UPDATE

EGG-TMI-7489  
December 1986

TMI-2 ACCIDENT SCENARIO UPDATE

This report summarizes the current best-estimate TMI-2 accident scenario describing the initial core heatup and degradation, continued degraded core heatup, and eventual core failure and migration of molten core materials into the reactor vessel lower plenum. Also included are discussions of fission product release, chemistry, and final postaccident distribution and inventory. The evidence indicates that the core damage and relocation occurred within 4 h of the accident initiation, after which the degraded reactor core was stable.

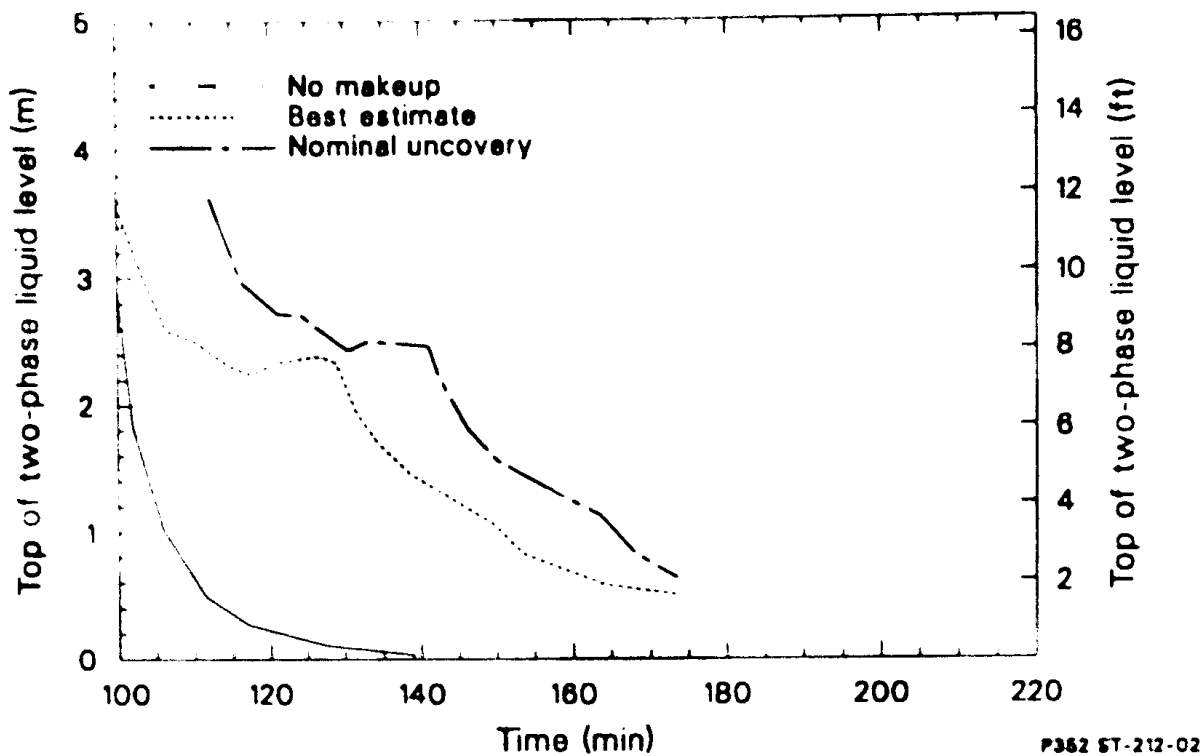
Figure 24. Summary of SCDAP calculations (assumed bounding cases for core liquid level and peak core temperatures).

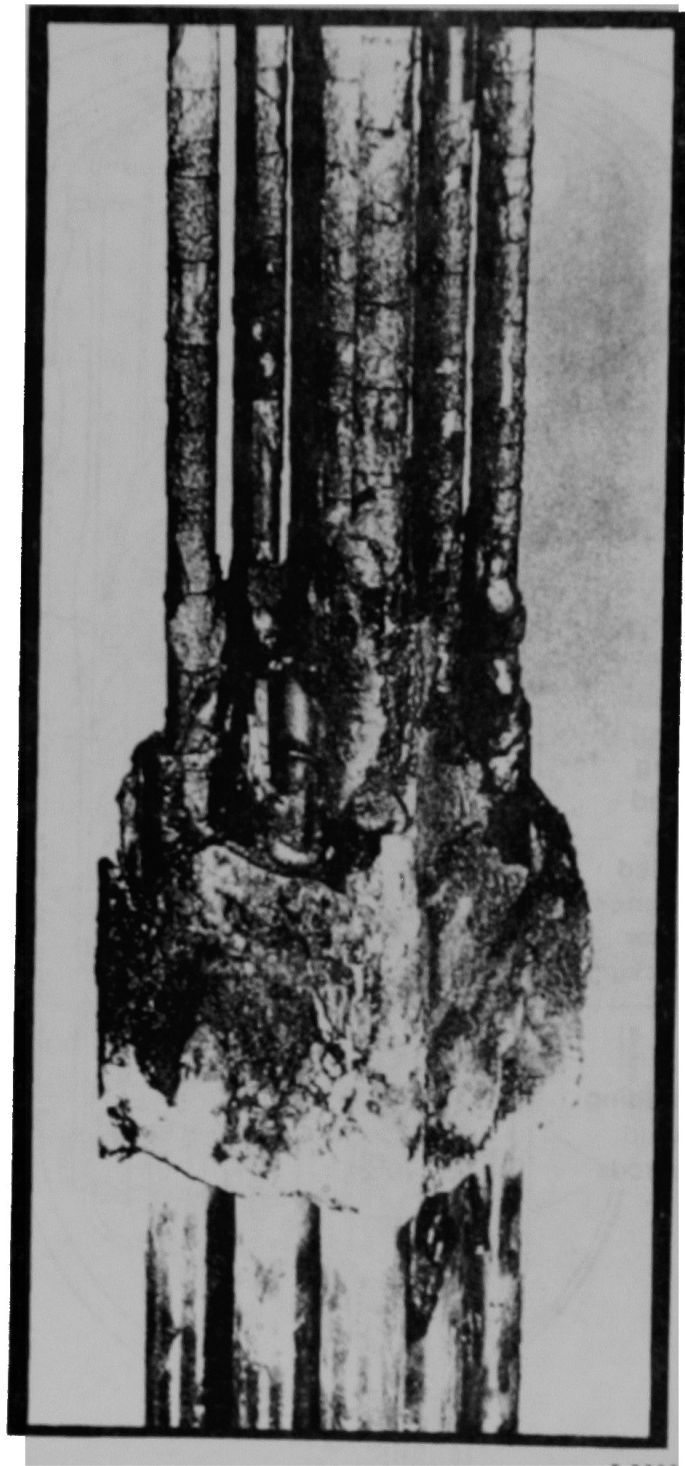
5 8608

Figure 25. End-state condition of fuel rods from ESBU-1 experiment (reproduced from Reference 24).
